Repair of cylinder block of main engine AKASAKA-MITSUBISHI

Repair of coupling mirror disk of engine 3D12

Repair of piston pump casing

Repair of cylinder block and casing of main engine Russian Diesel

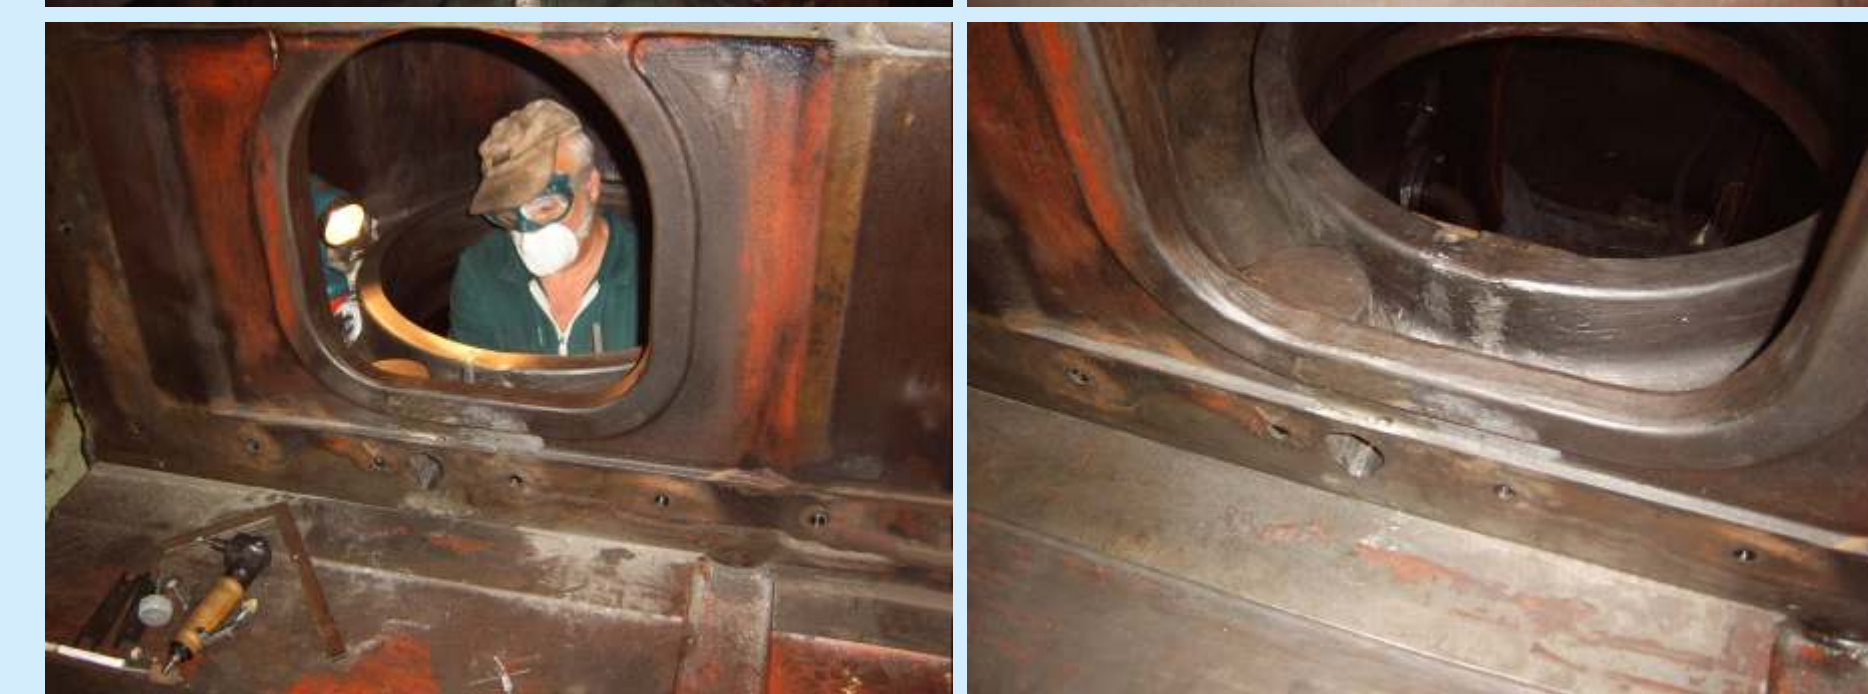
Moments from the Metallock repair on the cylinder block body fig.3 and 4)

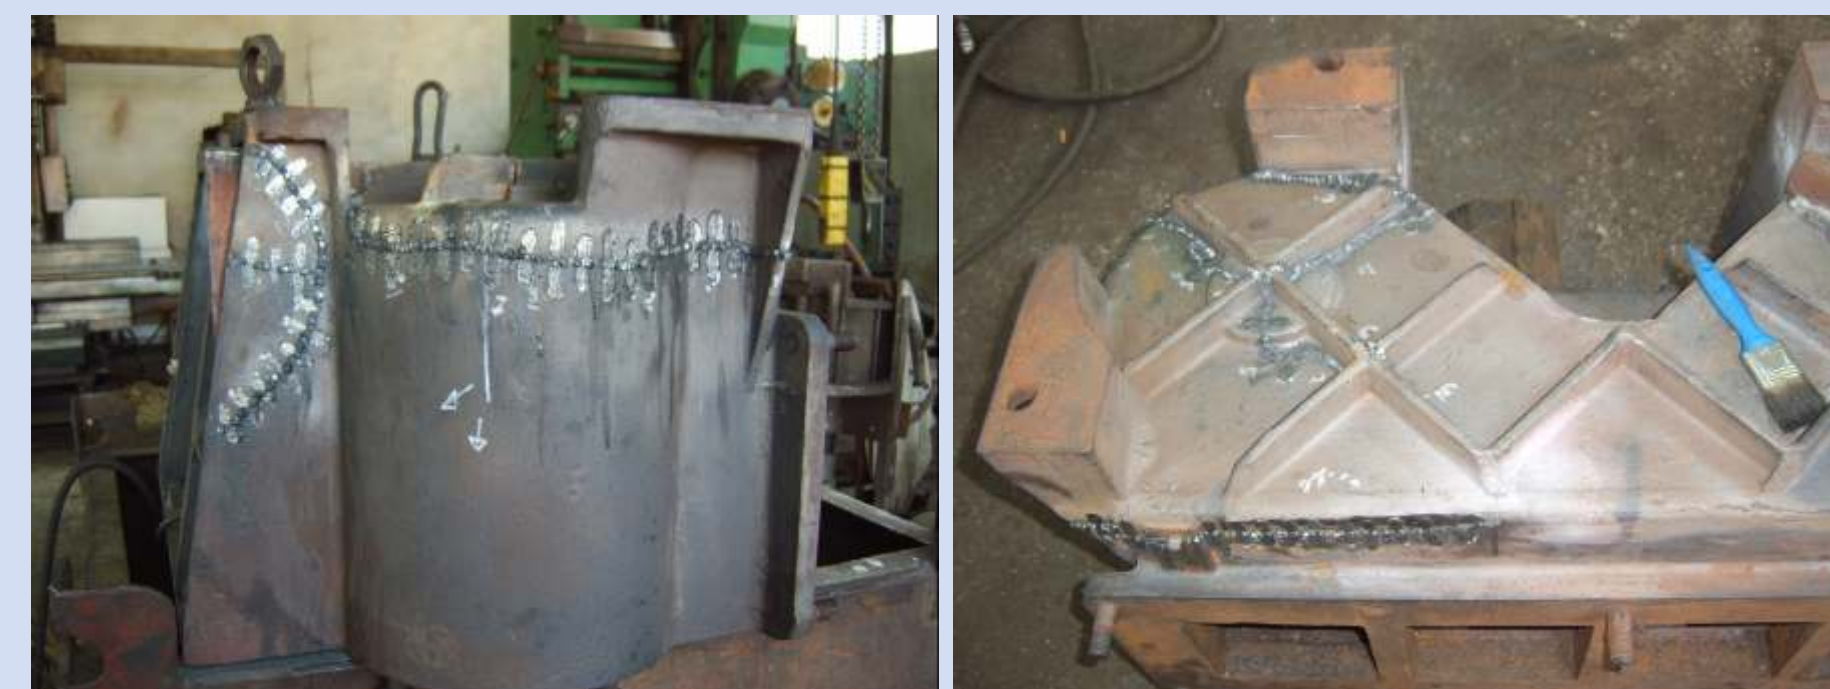
Stages of the Metallock repair of the piston pump casing (fig.3 and 4)

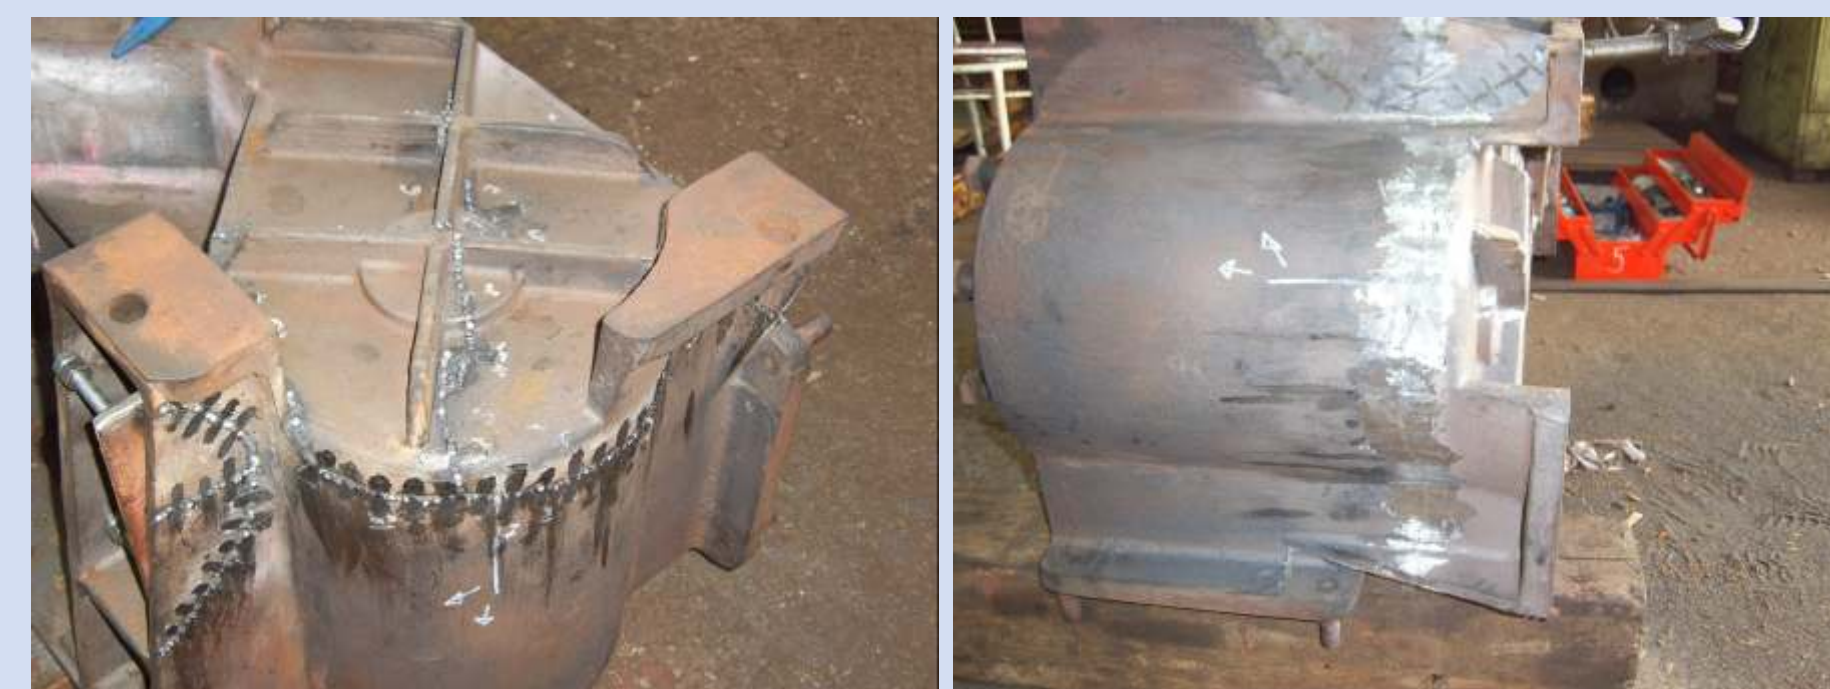
Moment of the Metallock repair of the piston pump casing (fig. 5)

Completed Metallock repair. Next is the test for repair quality by using penetrating liquid (fig.6)

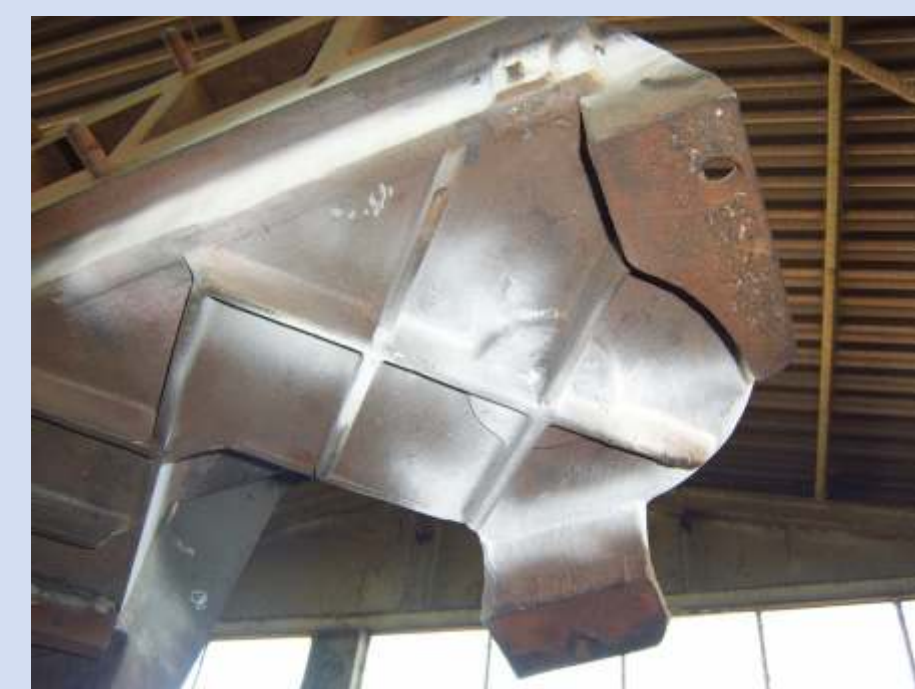
Test for repair quality (fig.7)
