METALOCK REPAIRS

VARNA MARITIME
www.varnamaritime.com

Repair of cylinder block Hitachi B&W

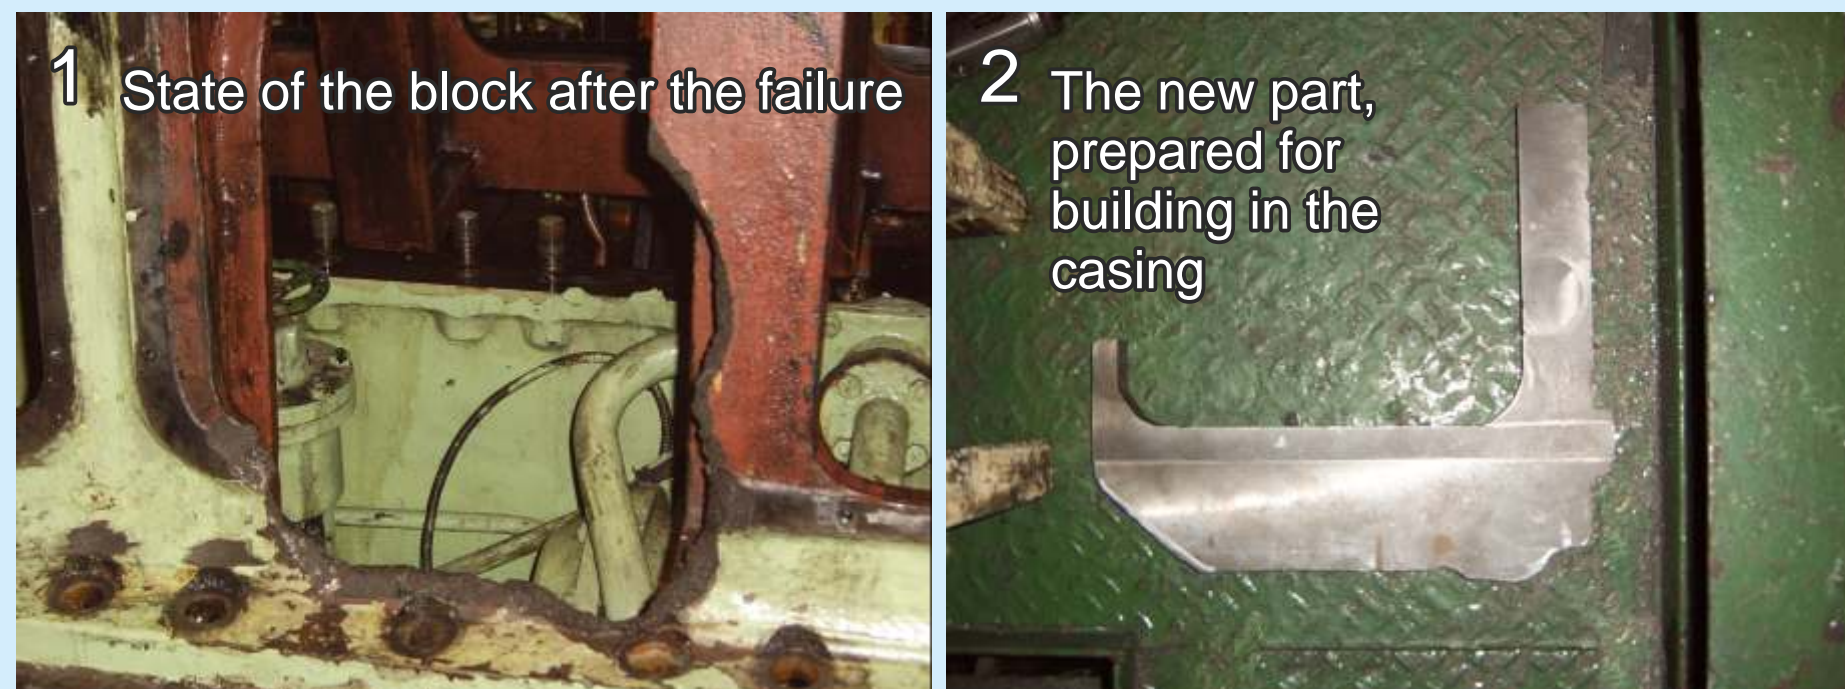
The STBD side of diesel generator (type Hitachi B&W) was destroyed in the area of third movement due to an operational failure (fig. 1).

The cylinder block was repaired on place through Metalock technology. For the repair purposes a new casting of the missing part of the wall was fabricated (fig. 2).

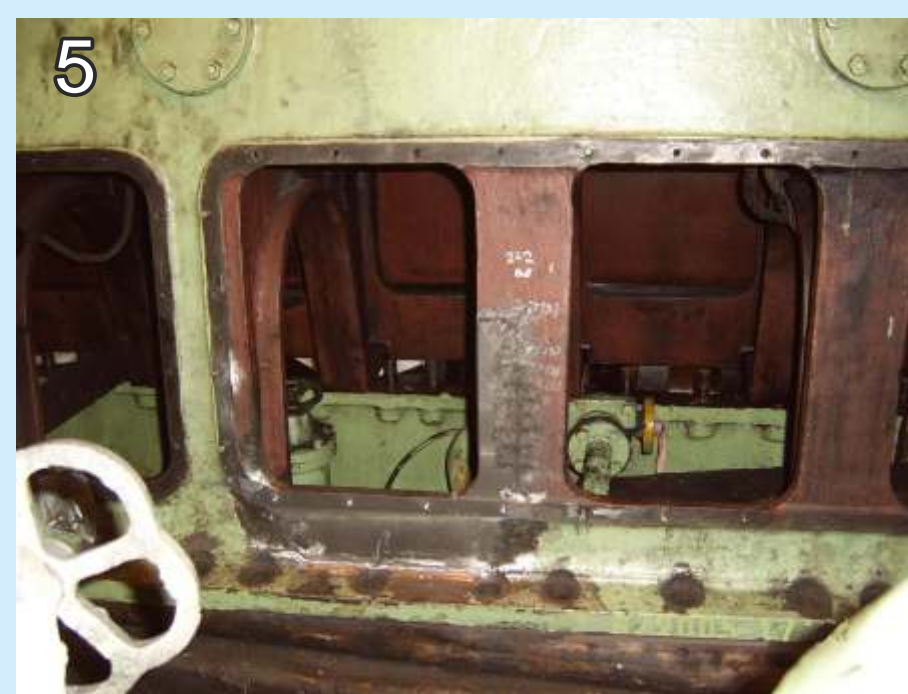
The completed Metalock repair before the final assembly of the generator

The repair was successfully fulfilled on time (fig. 5) and surveyed by authorized inspector. As a result of the used technology the diesel generator works with 100% of its capacity.

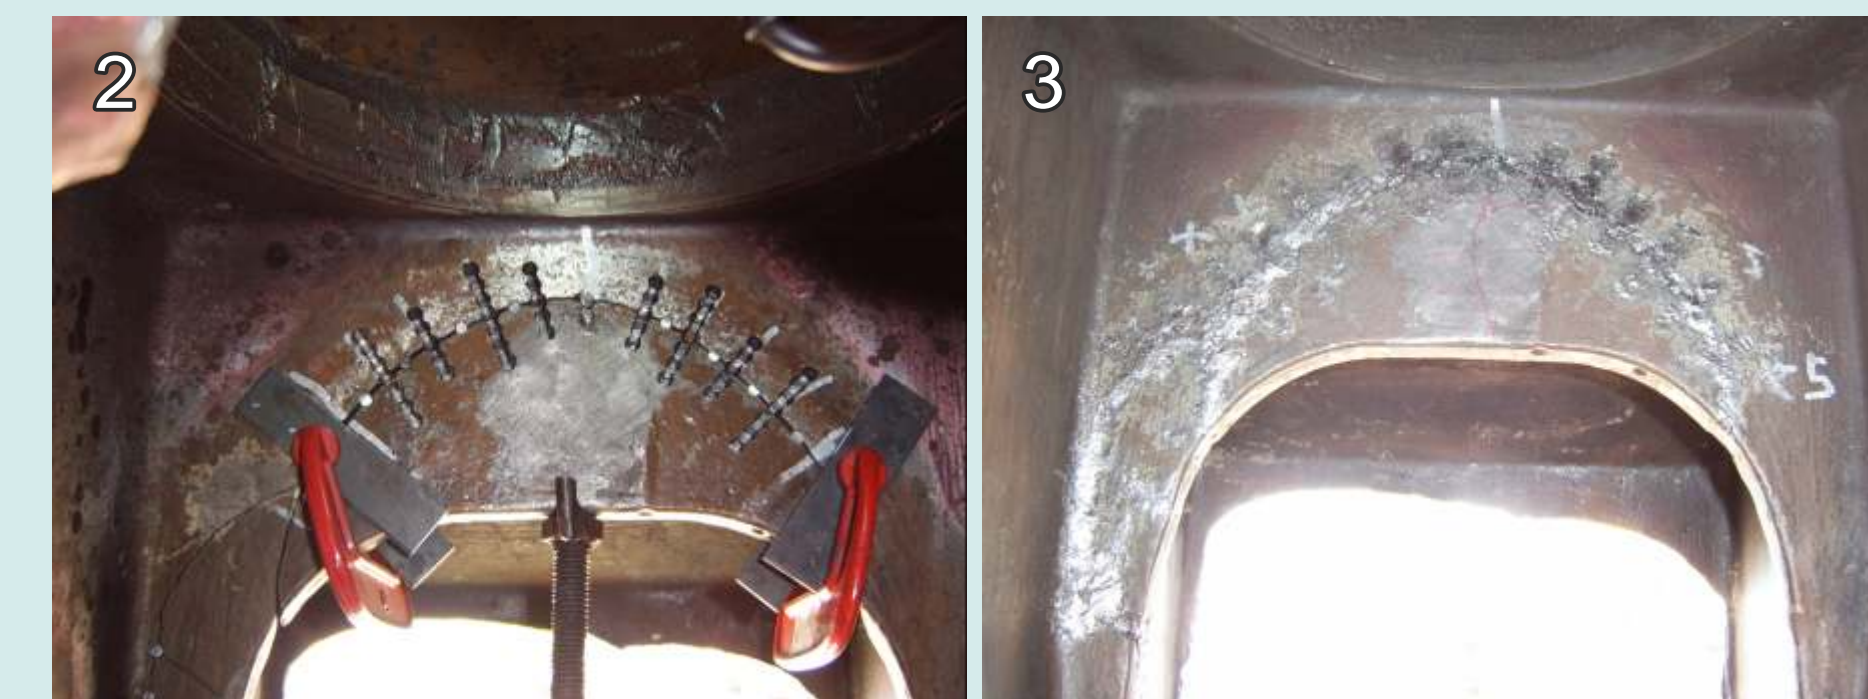
Diesel generator (type „Sulzer“ 5AL25/30) was seriously damaged due to torn bolt on connecting rod bearing of movement No3. As result from the break the inner frames and walls on the both sides were destroyed (fig. 1).

Cylinder block before repair

Moment from the repair works and restored inner right frame (fig.2, 3)

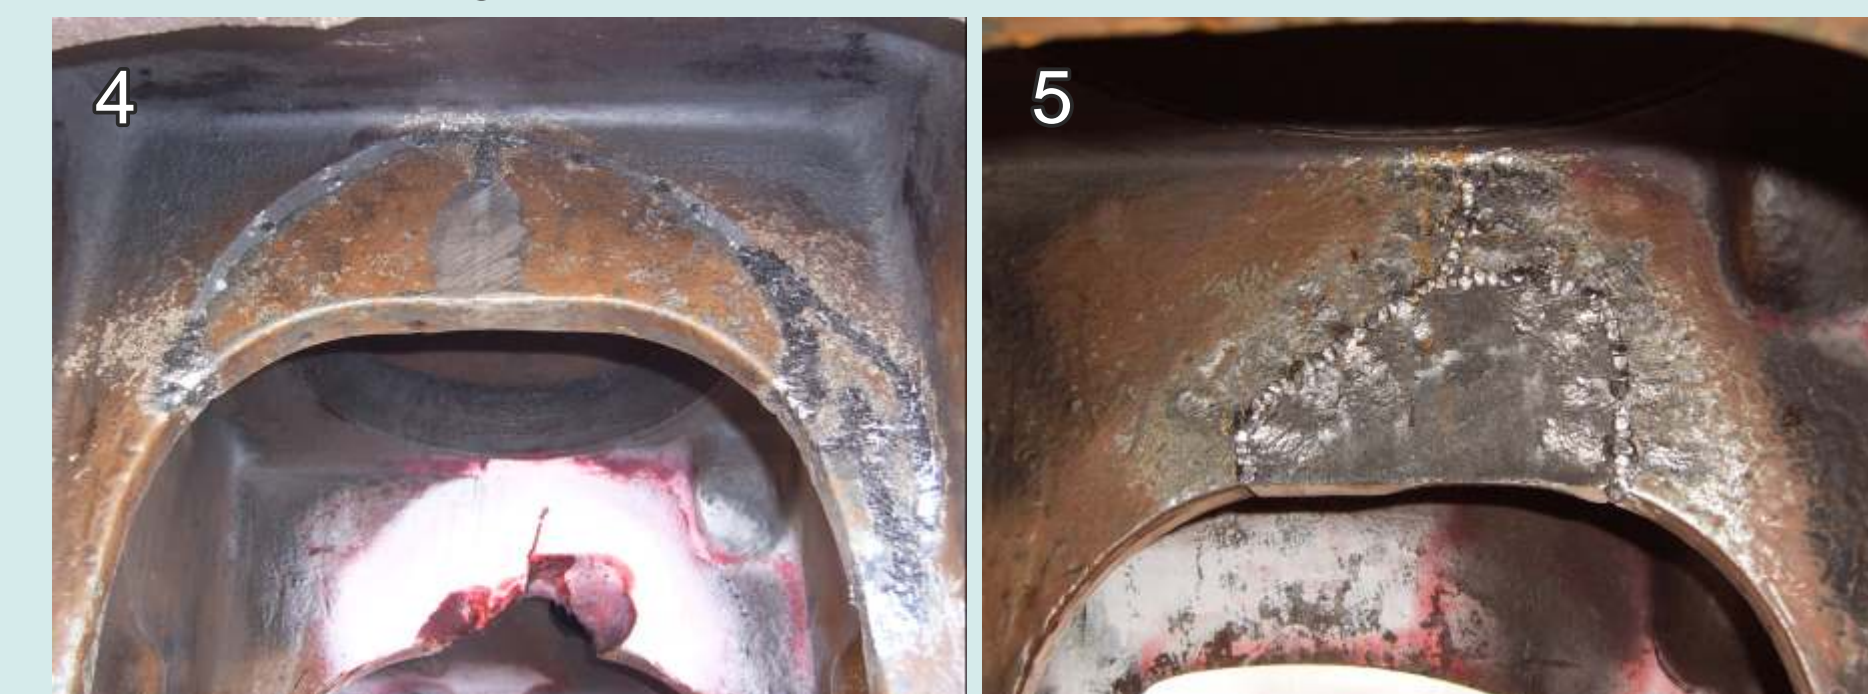
Crack test on the limited crack and moment from the repair process of inner left frame (fig.4, 5)

Restored inner frames

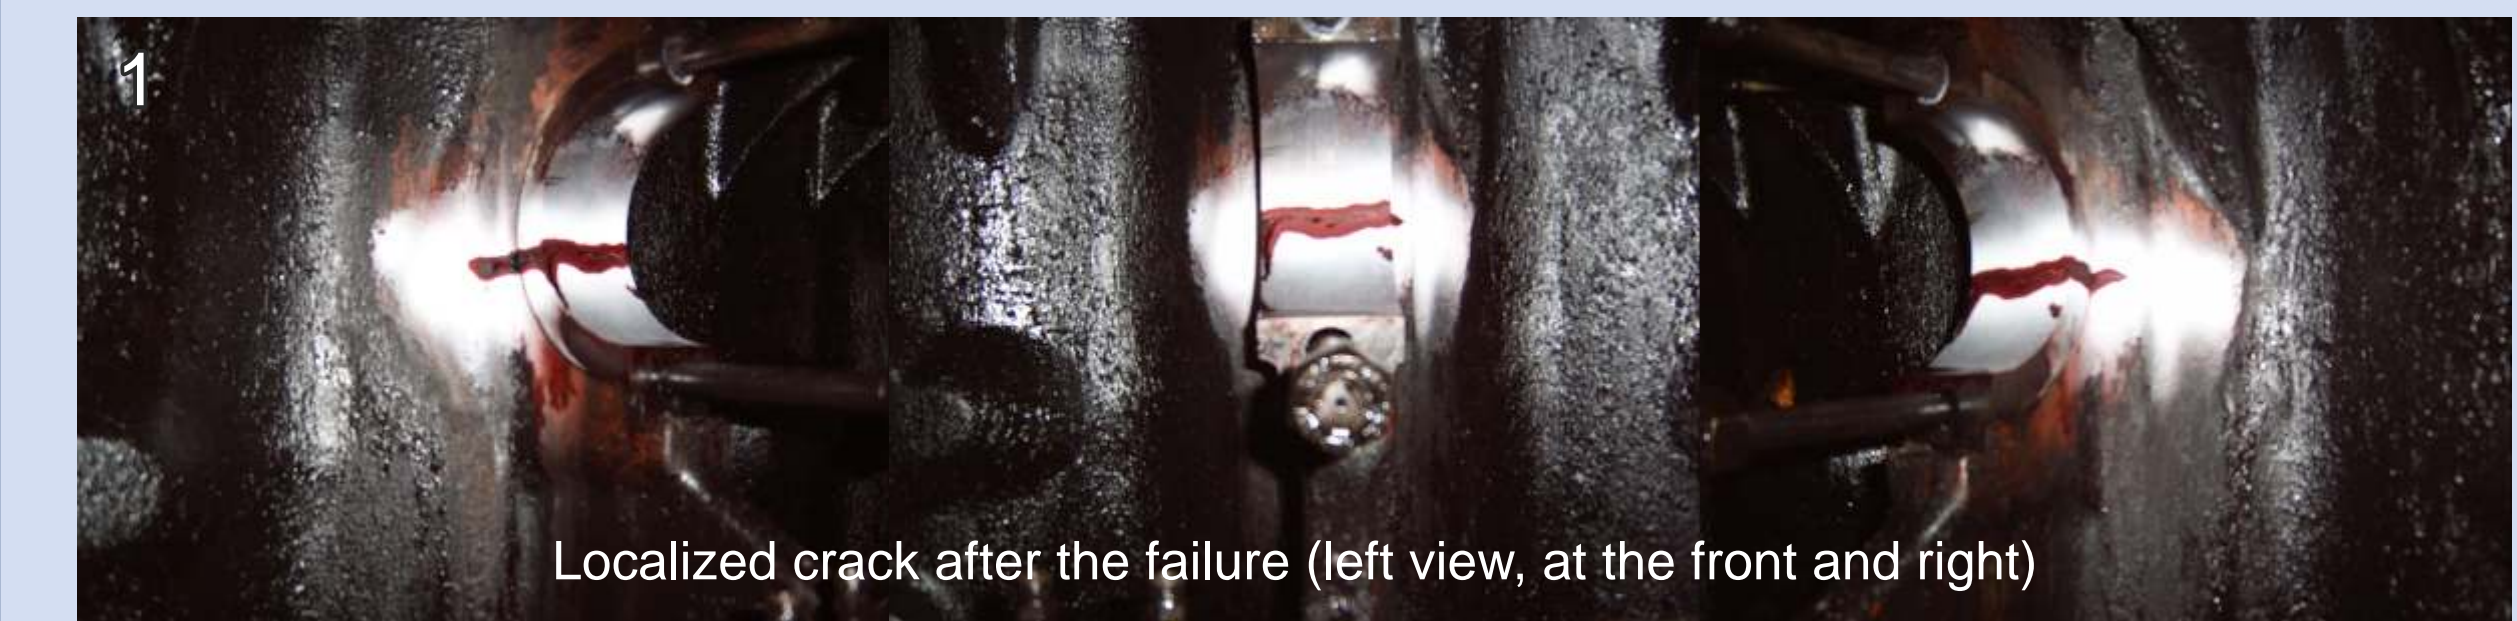
Due to a failure a crack appeared on the camshaft bearing seat No7 of ME "Mak" (fig.1). The crack was limited and restored using the Metalock method (fig.2).

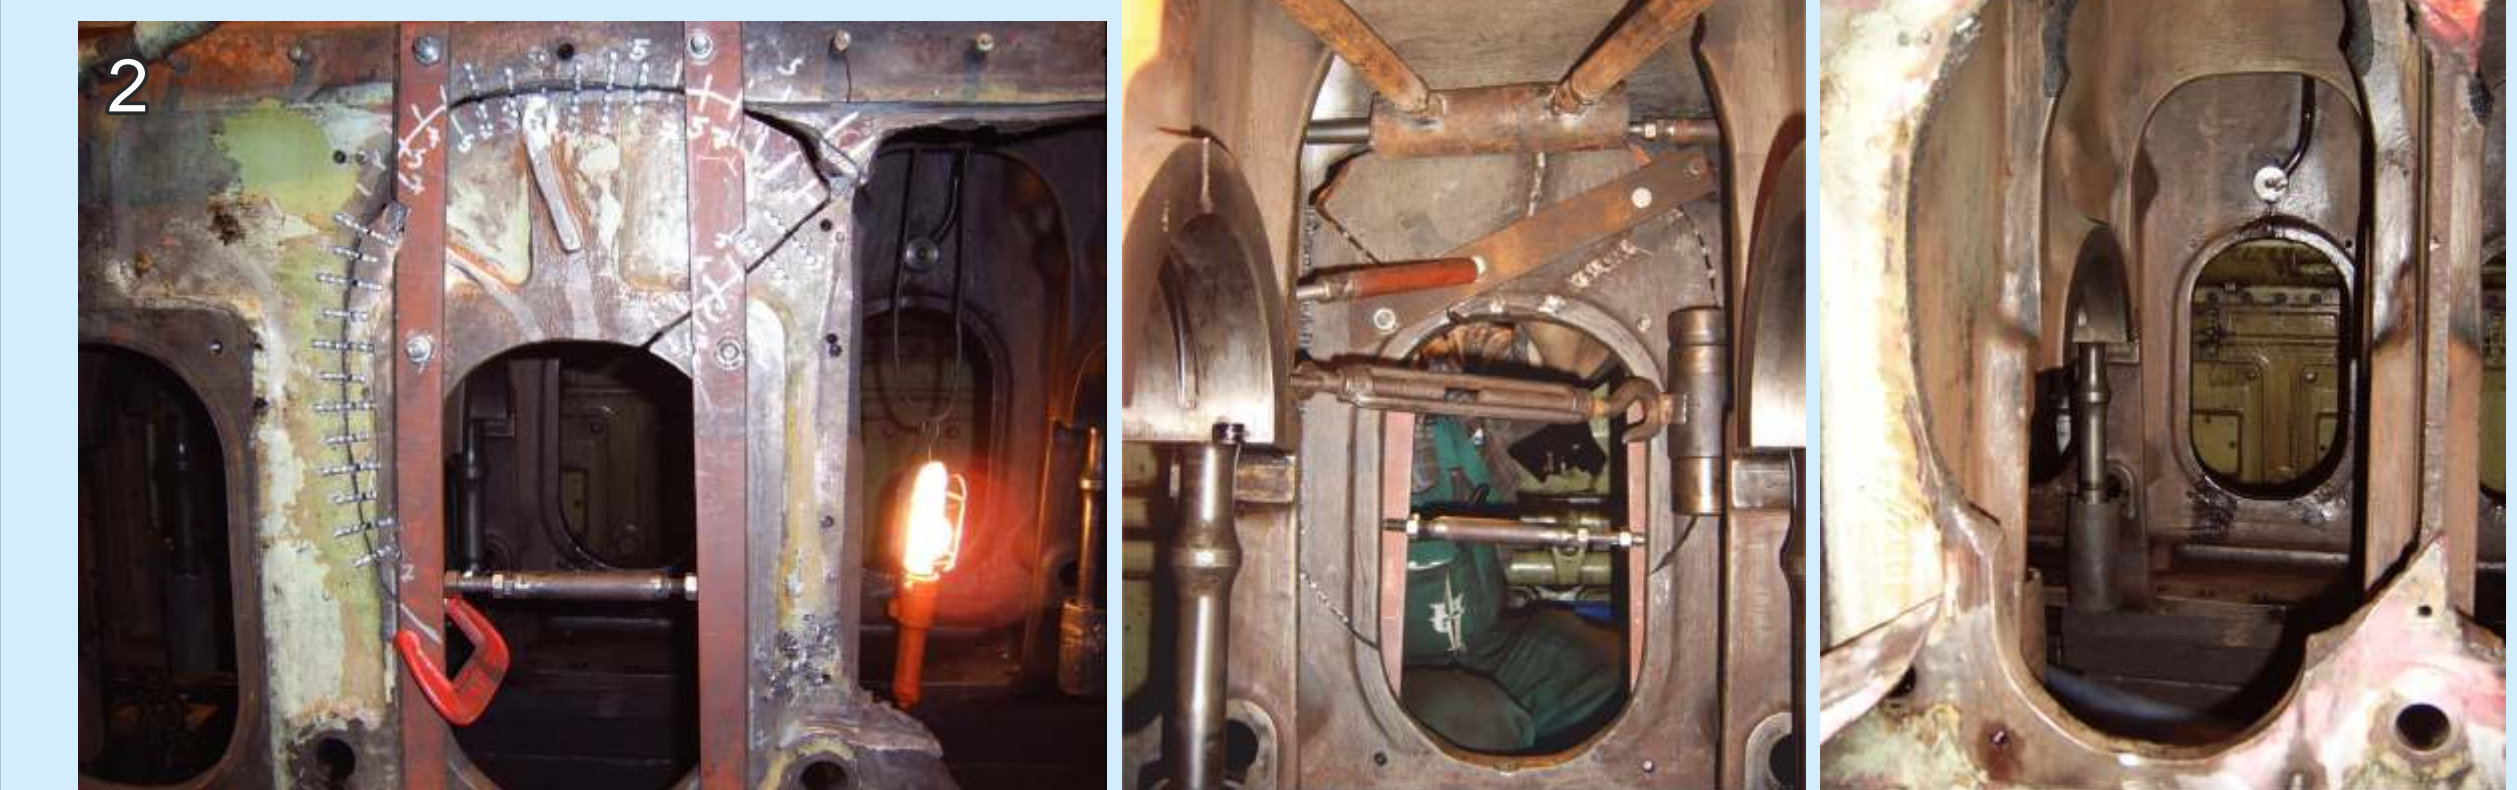
STBD side of diesel generator (type "Sulzer" 5AL25/30) was destroyed in the area of movement No4 due to the operational failure (fig.1).

On figures 2 and 3 is seen the way through which the broken wall parts were fixed (outside and inside).
