## Repair of Zgoda Sulzer diesel unit cylinder block and casing

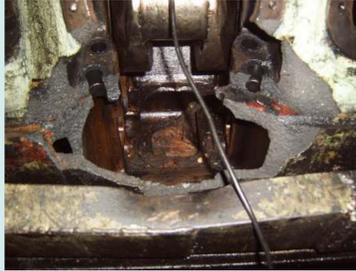
Diesel generator cylinder block and casing during the performed inspection and before commencement of repair works. (fig.1)

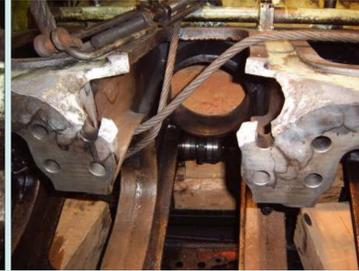
The broken part of the cylinder block. For cylinder block restoration, first it was necessary to restore its construction. (fig.2)

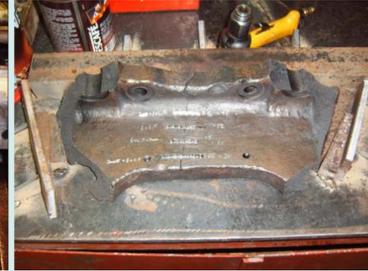
Prepared surface of the cylinder block missing part. (fig.3)

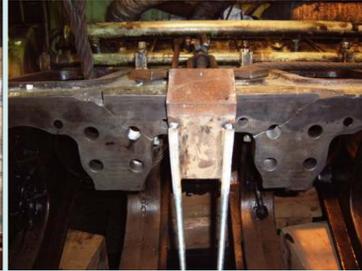
The missing part is built in and tightened to the cylinder block. This is crucial requirement for the successful restoration of casing through the Metalock method. (fig.4)

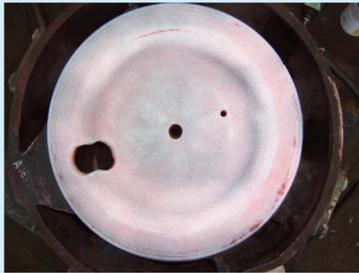
Cylinder head of diesel generator with a crack, localized by colour deflection

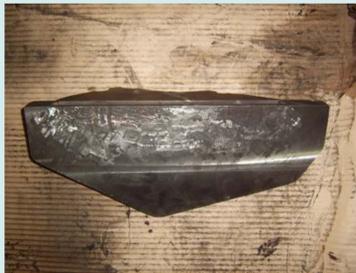
The damaged part to which new material was added as to enable restoration of casing wall. The new detail was fabricated of cast iron and was embedded in the broken part of the casing, using the METALOCK method. (fig.7)

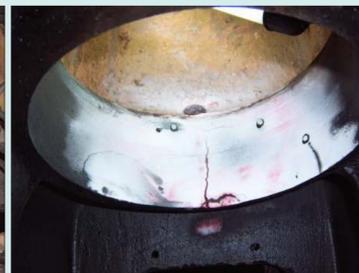
Localization and limited cracks on the cylinder liner. (fig. 14)

The third direction of the repair that was performed simultaneously to the restoration of the other two parts of the generator, damaged during an accident, was the cylinder liner of forth motion, particularly in the area below the packing surfaces of the cooling space.

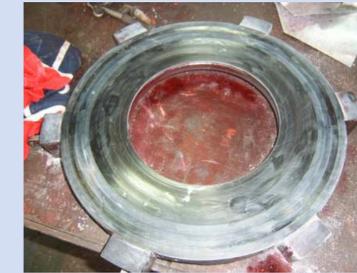
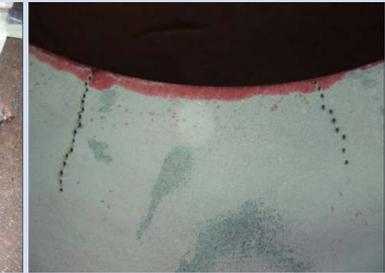
The mirror disk before machining

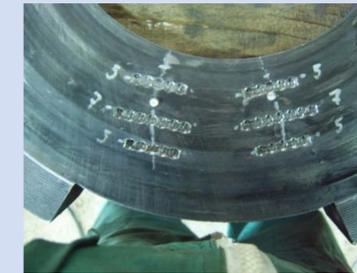
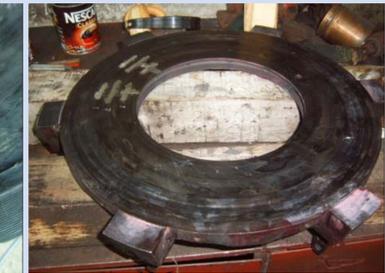
Cracks localized through colour deflection

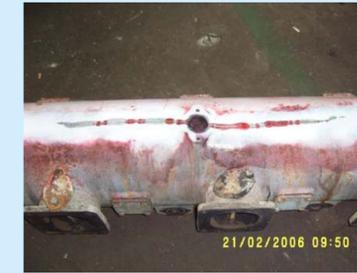
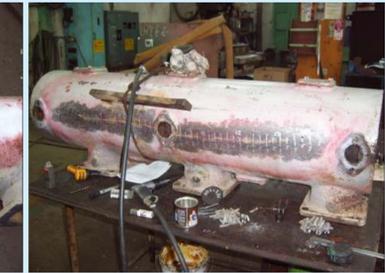
Removed collector with localized crack before the beginning of repair (fig.1)

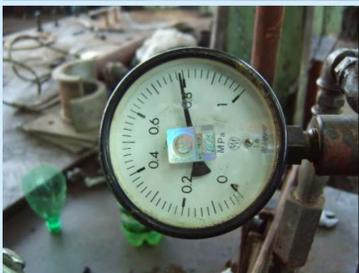
Hydraulic test of repaired cylinder head. Testing pressure of fluid is 0,8 MPa.
