Repair of cylinder block of main engine AKASAKA-MITSUBISHI

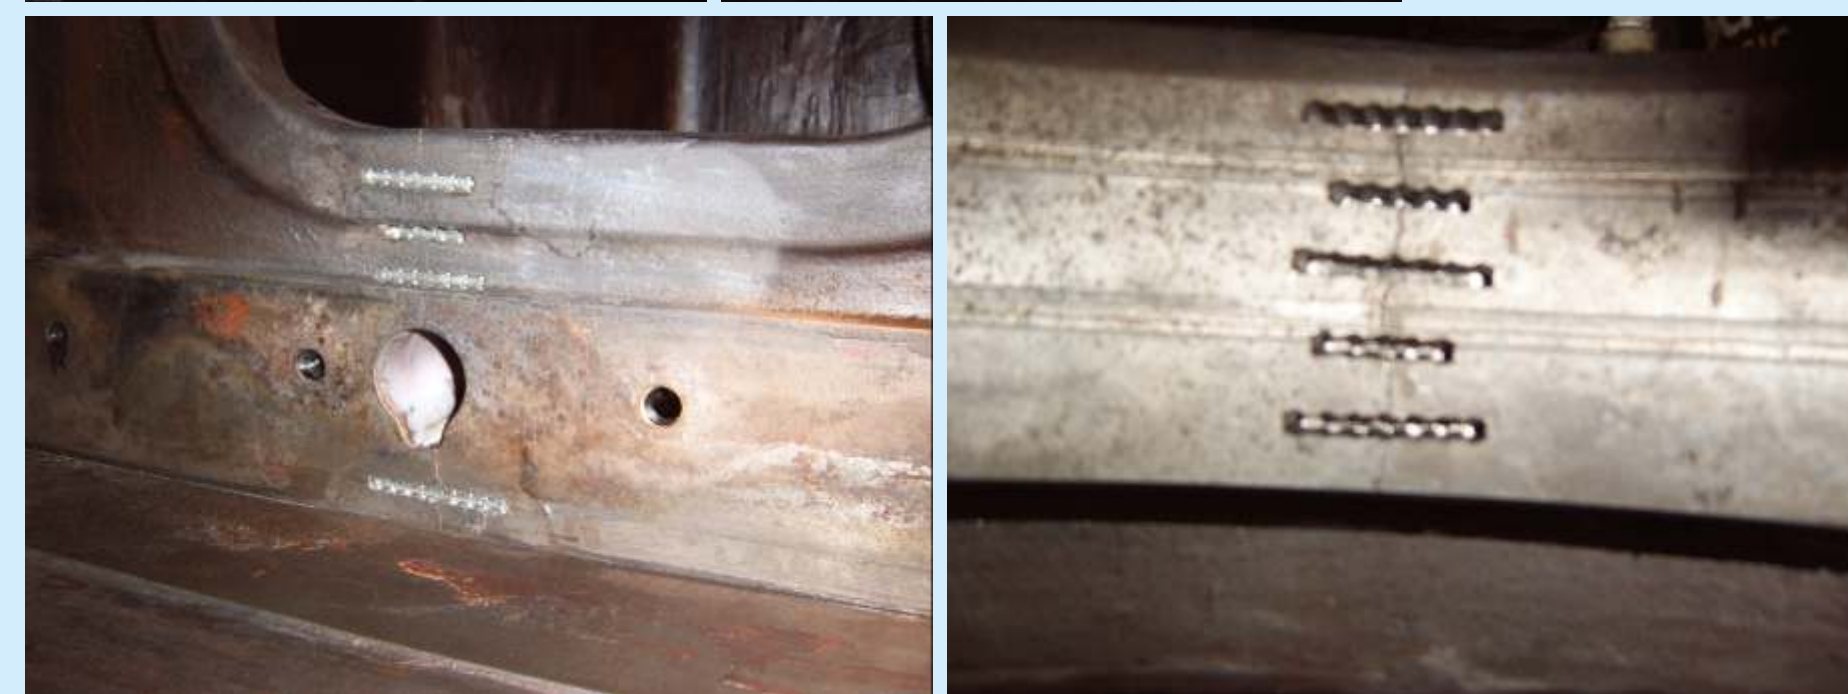
As a result of failure during operation a crack has emerged in the area of the sixth motion on the cylinder block of main engine „AKASAKA-MITSUBISHI“ 6UET52/90C (Figures 1 and 2)

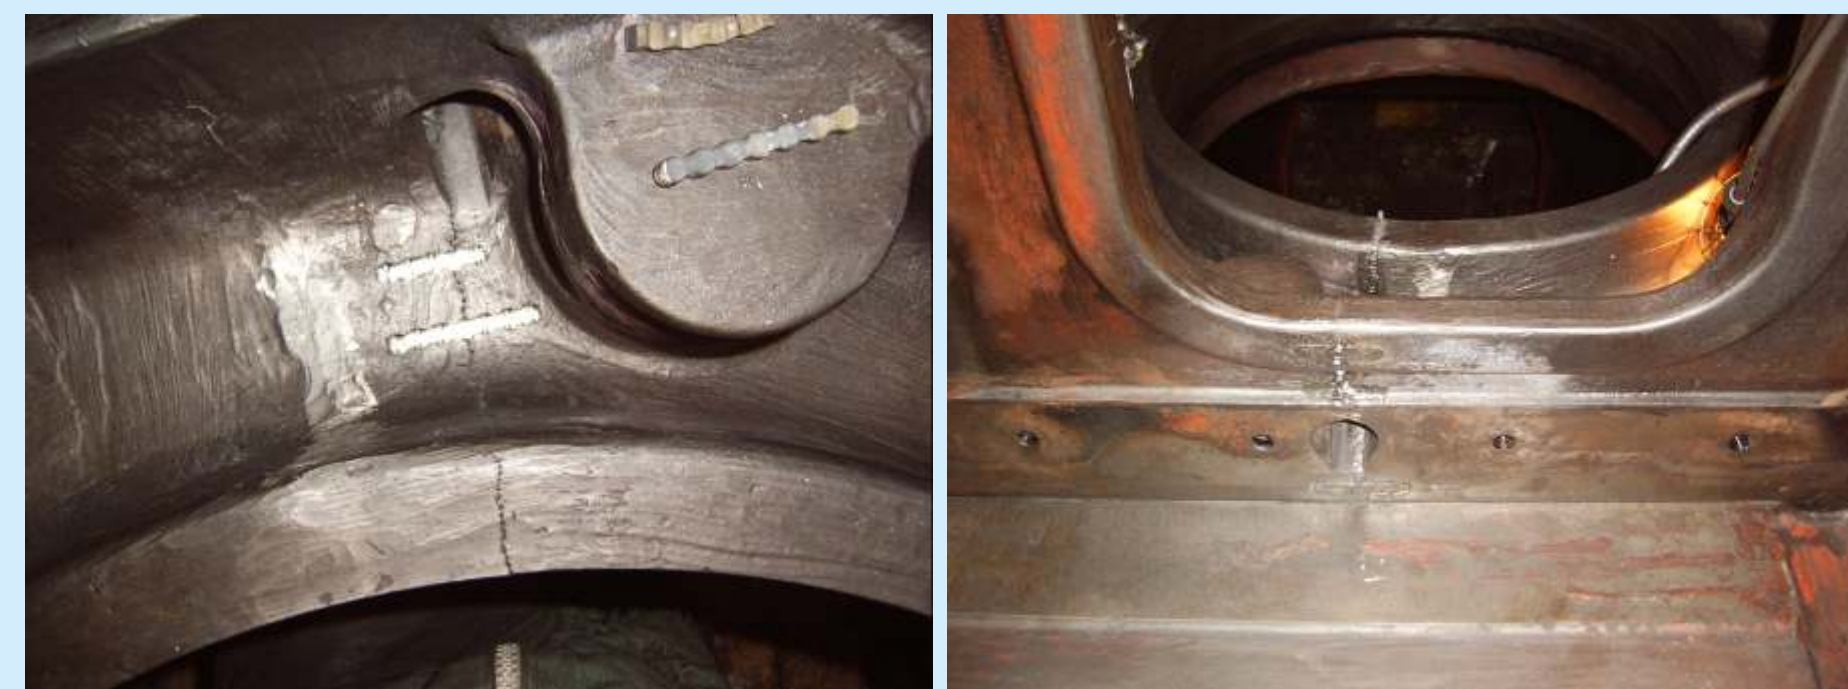
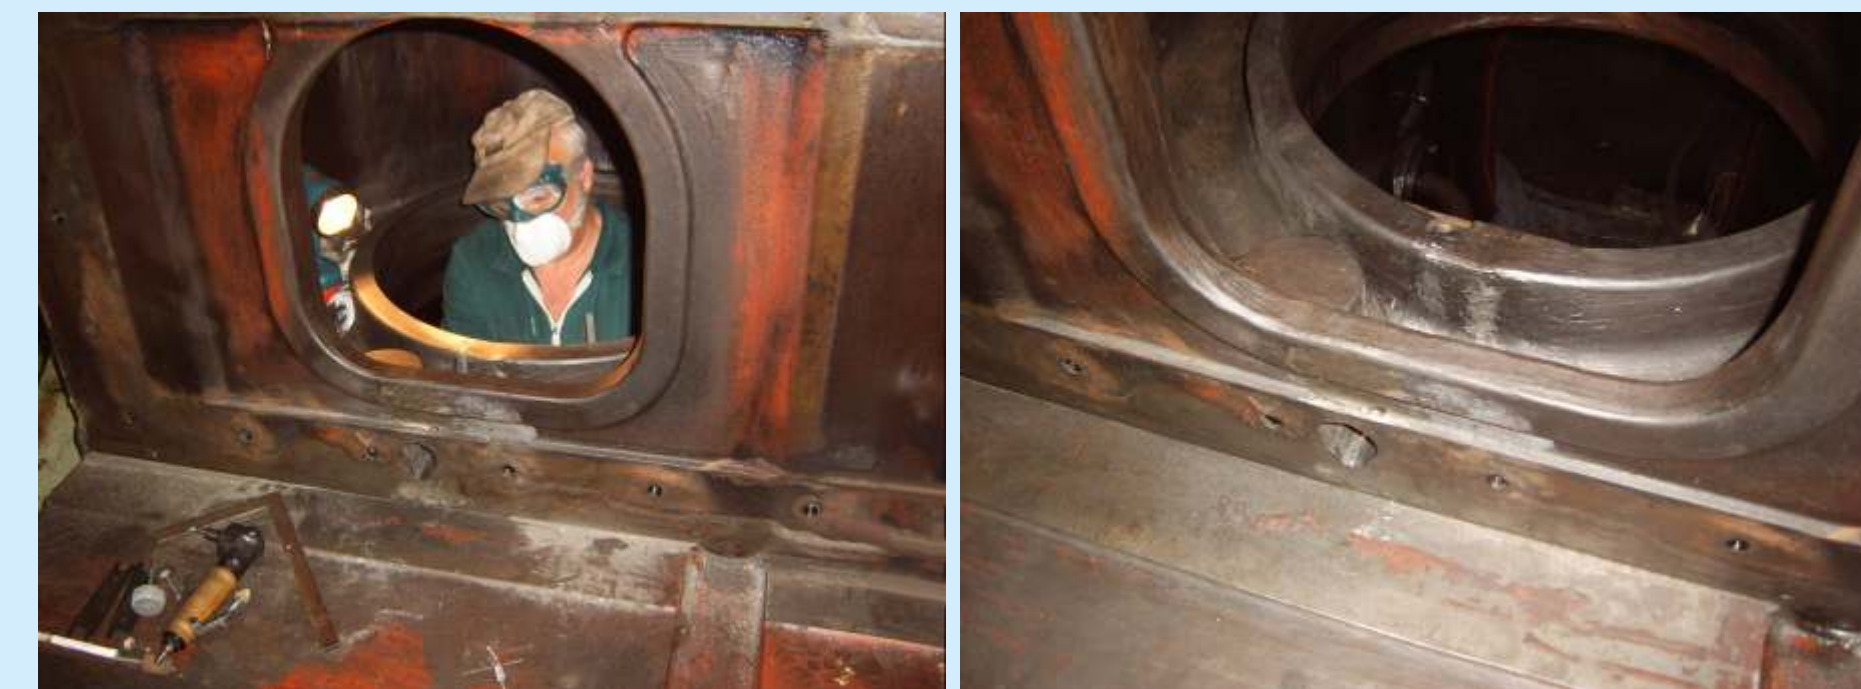
Moments from the Metallock repair on the cylinder block body fig.3 and 4)

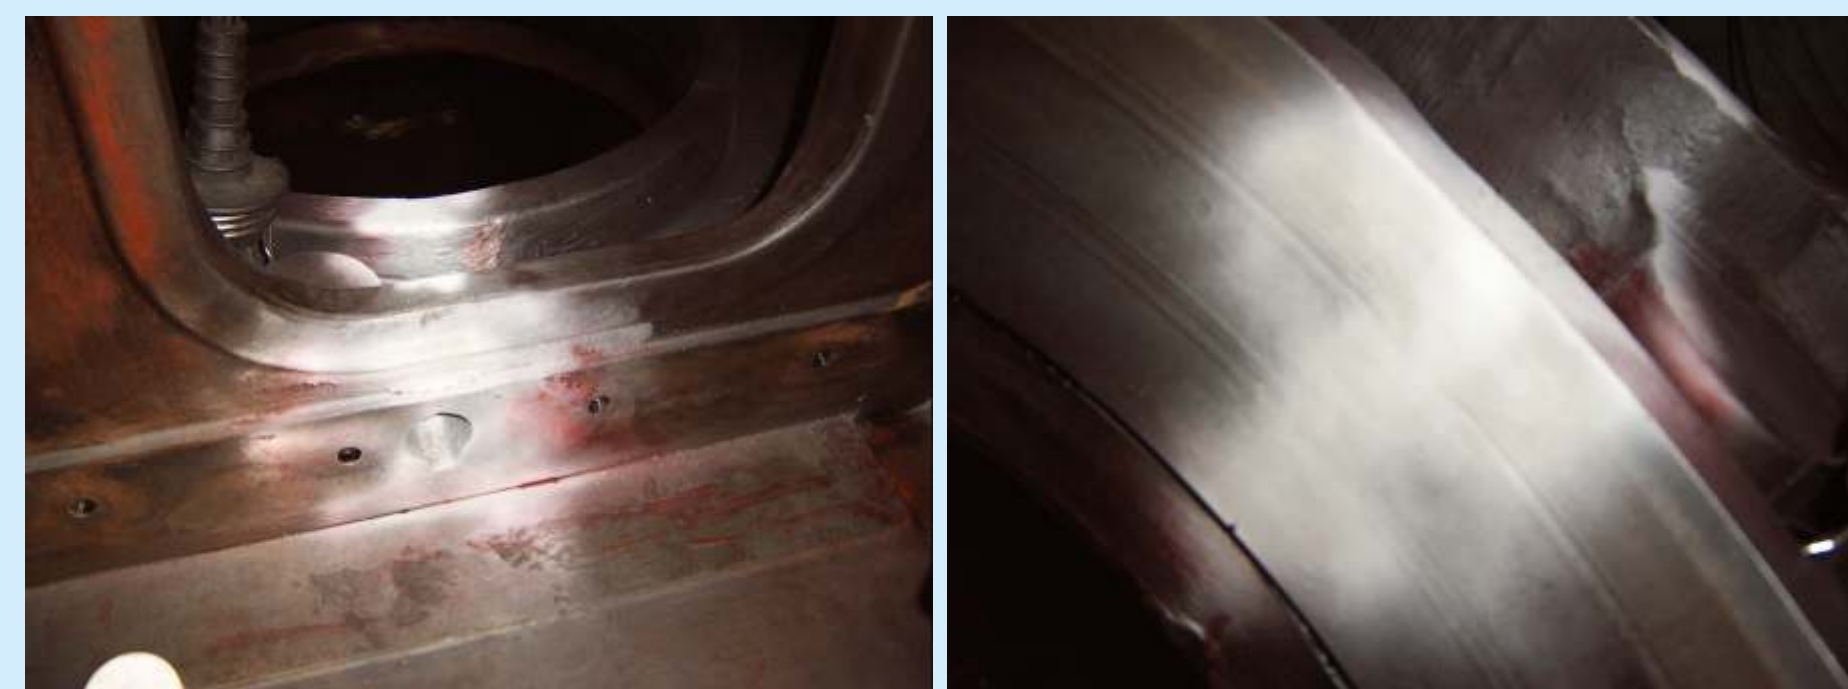
Final touches of machining on the reconstructed body after the crack repair (fig.7 and 8)

Fuality test of the repair (fig.9 and 10)

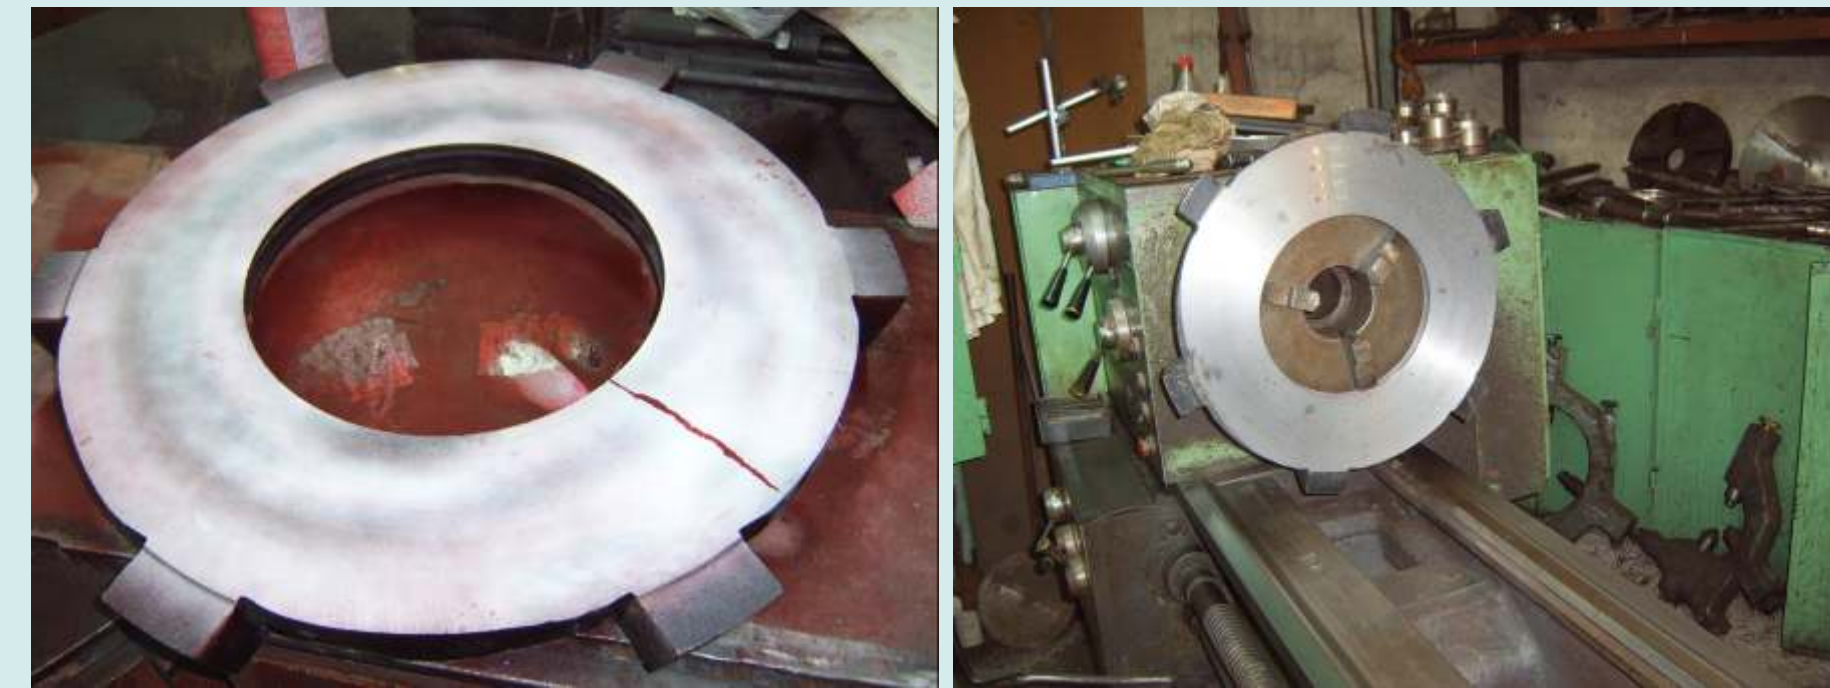
Condition of the disk at delivery for repair (fig.1)

Mechanical treatment of the disk after the performed Metallock repair

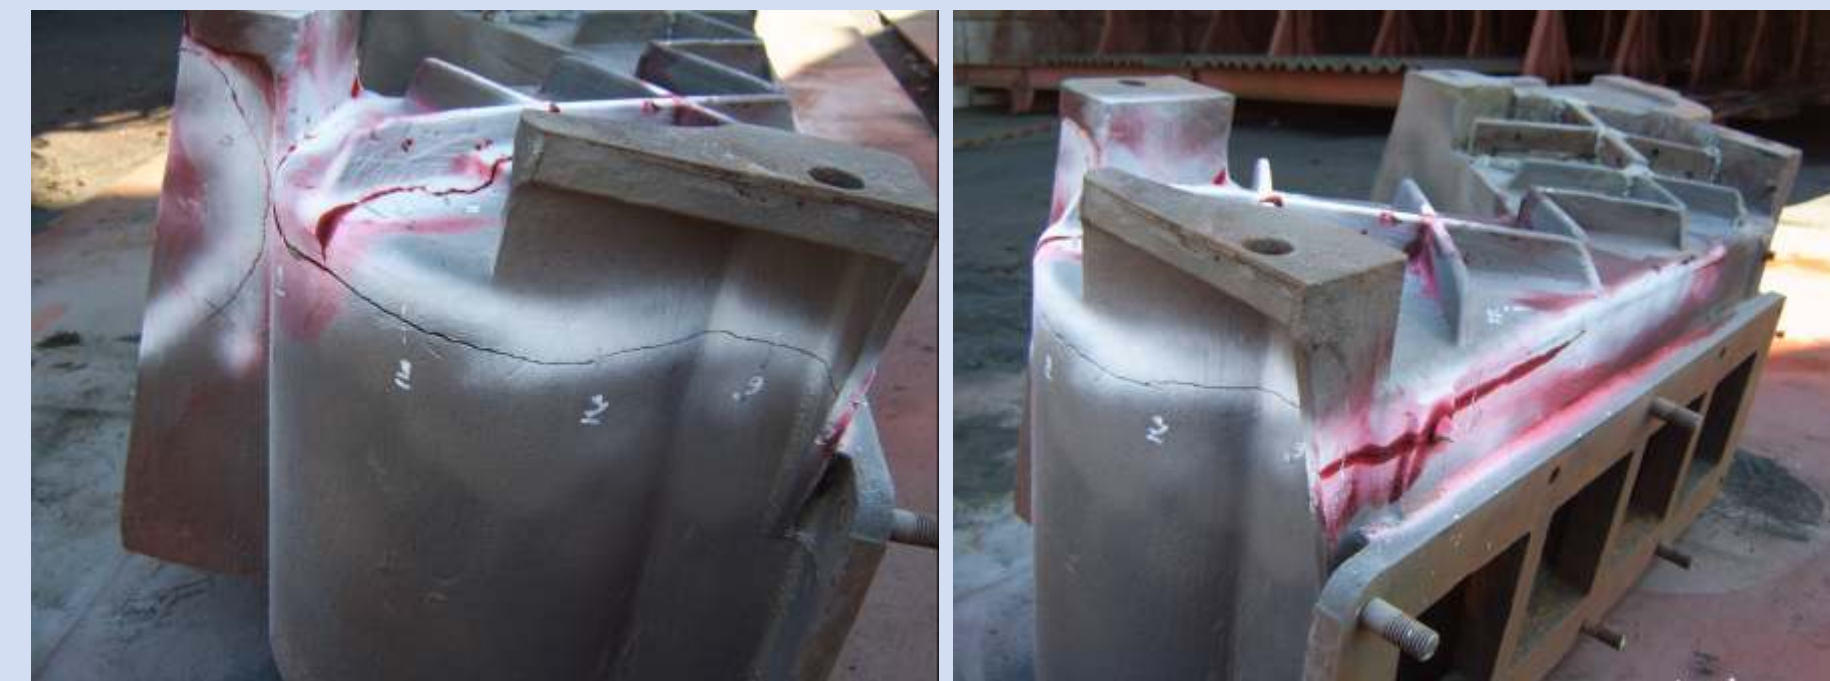
Condition of pump casing at delivery for repair (fig. 1 and 2)

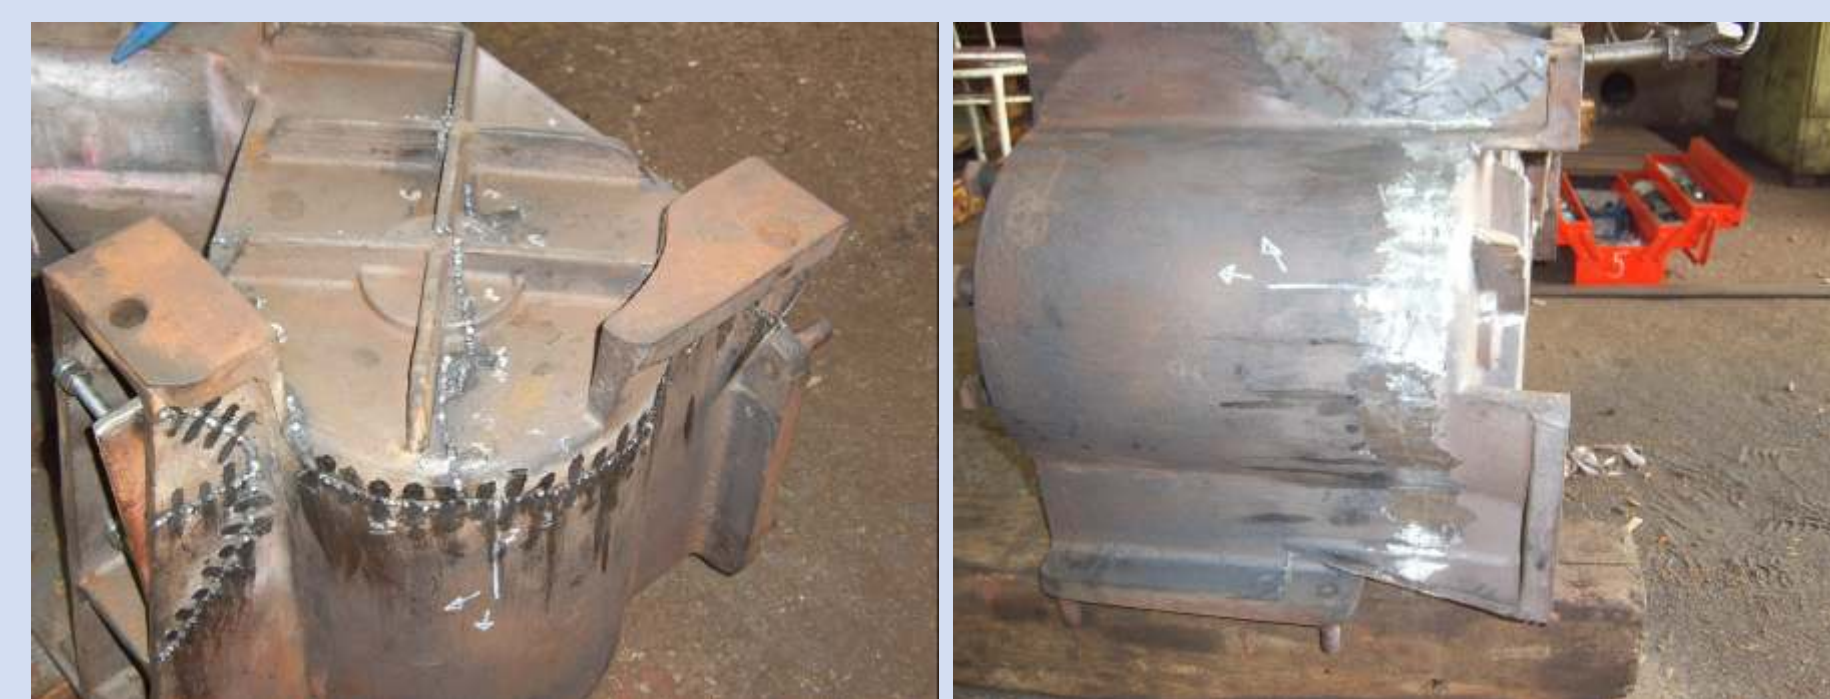
Moment of the Metallock repair of the piston pump casing (fig. 5)

Completed Metallock repair. Next is the test for repair quality by using penetrating liquid (fig.6)

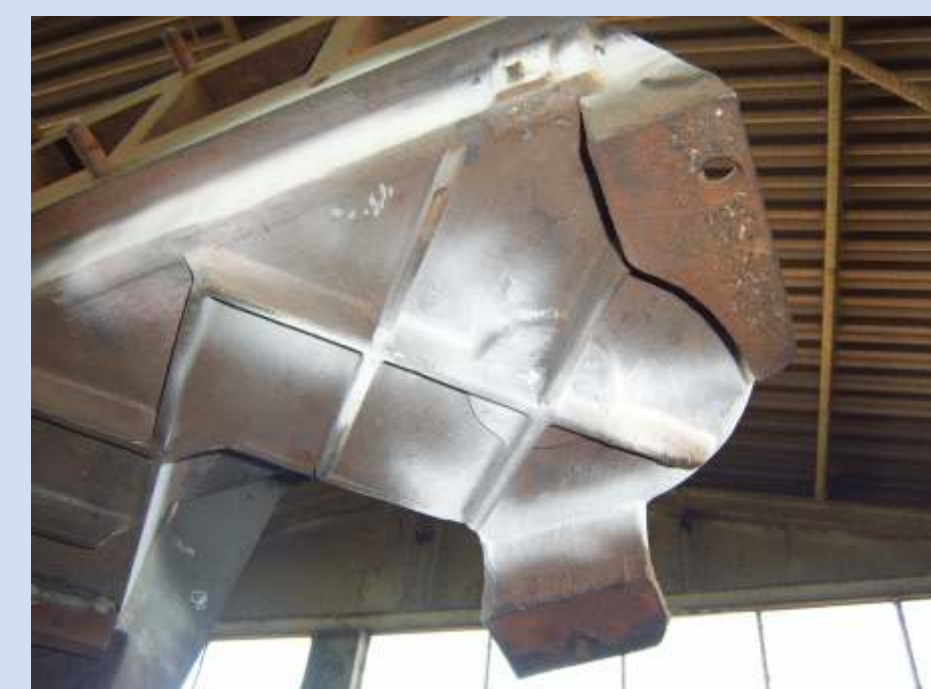
Test for repair quality (fig.7)

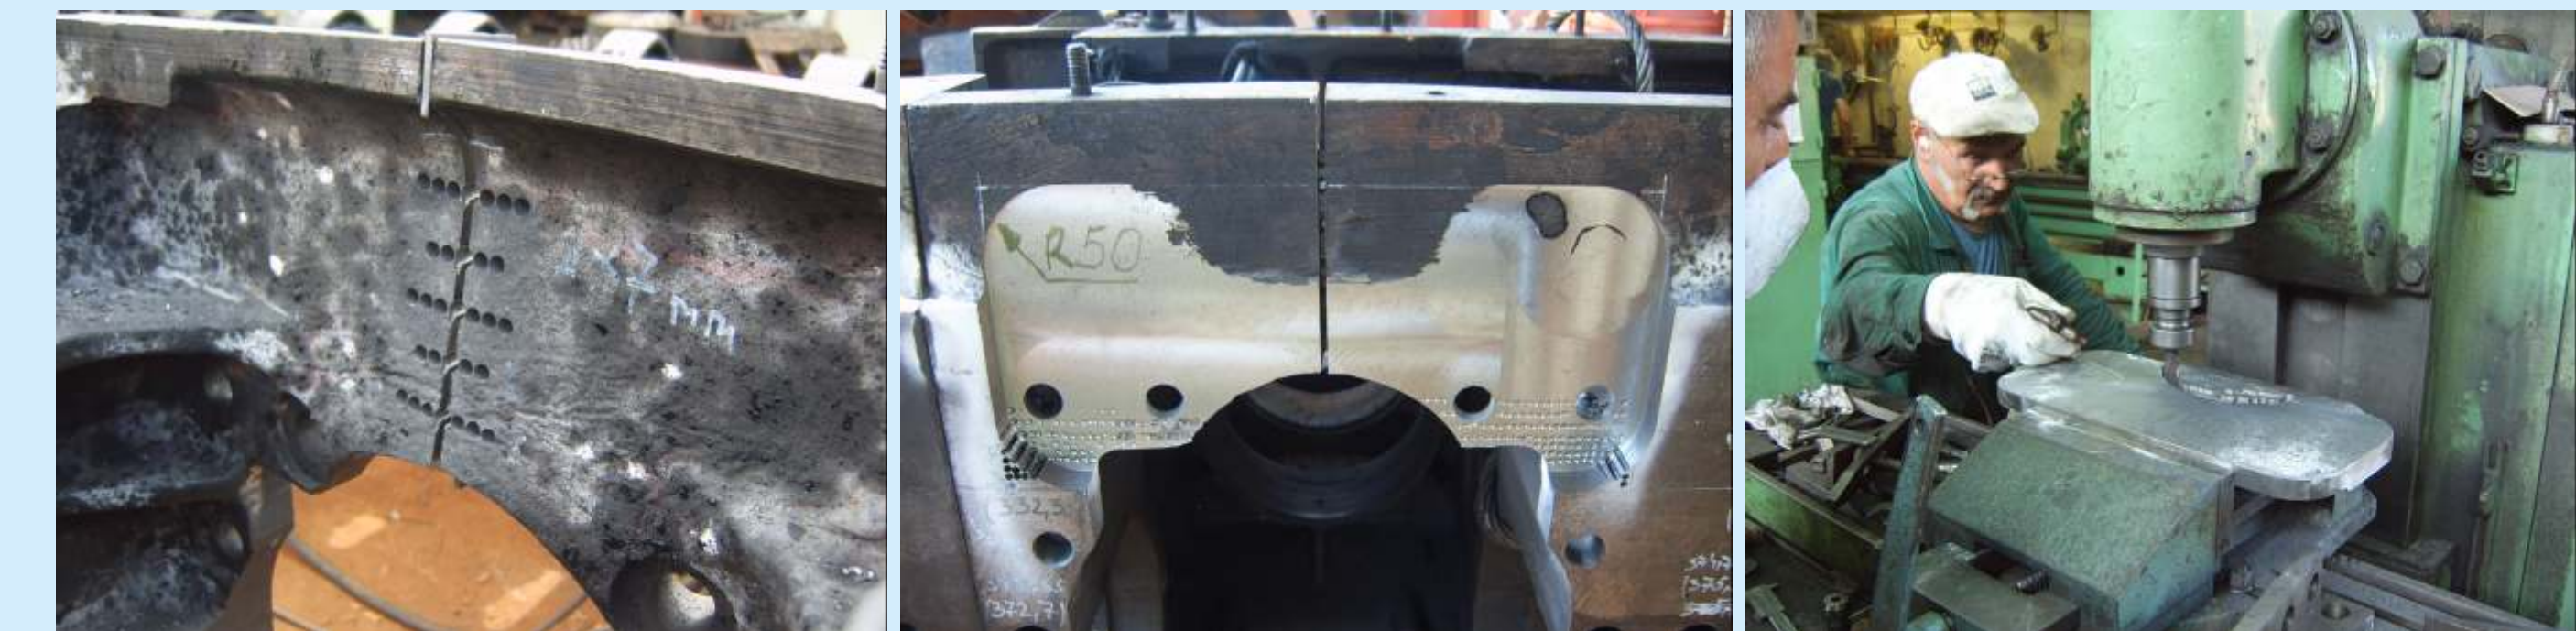
Due to the failure the face of the cylinder block is disturbed. This required a transverse cut to be made in order to release the tensions and for restoration of sizes. As it could be seen on fig. 1 that section was restored using the Metallock method.

The block face to the casing was supplied with bed for insert, compensating the plastic deformations, resulting from the failure (fig.2)

Moment of the mechanical processing of the insert (fig.3)

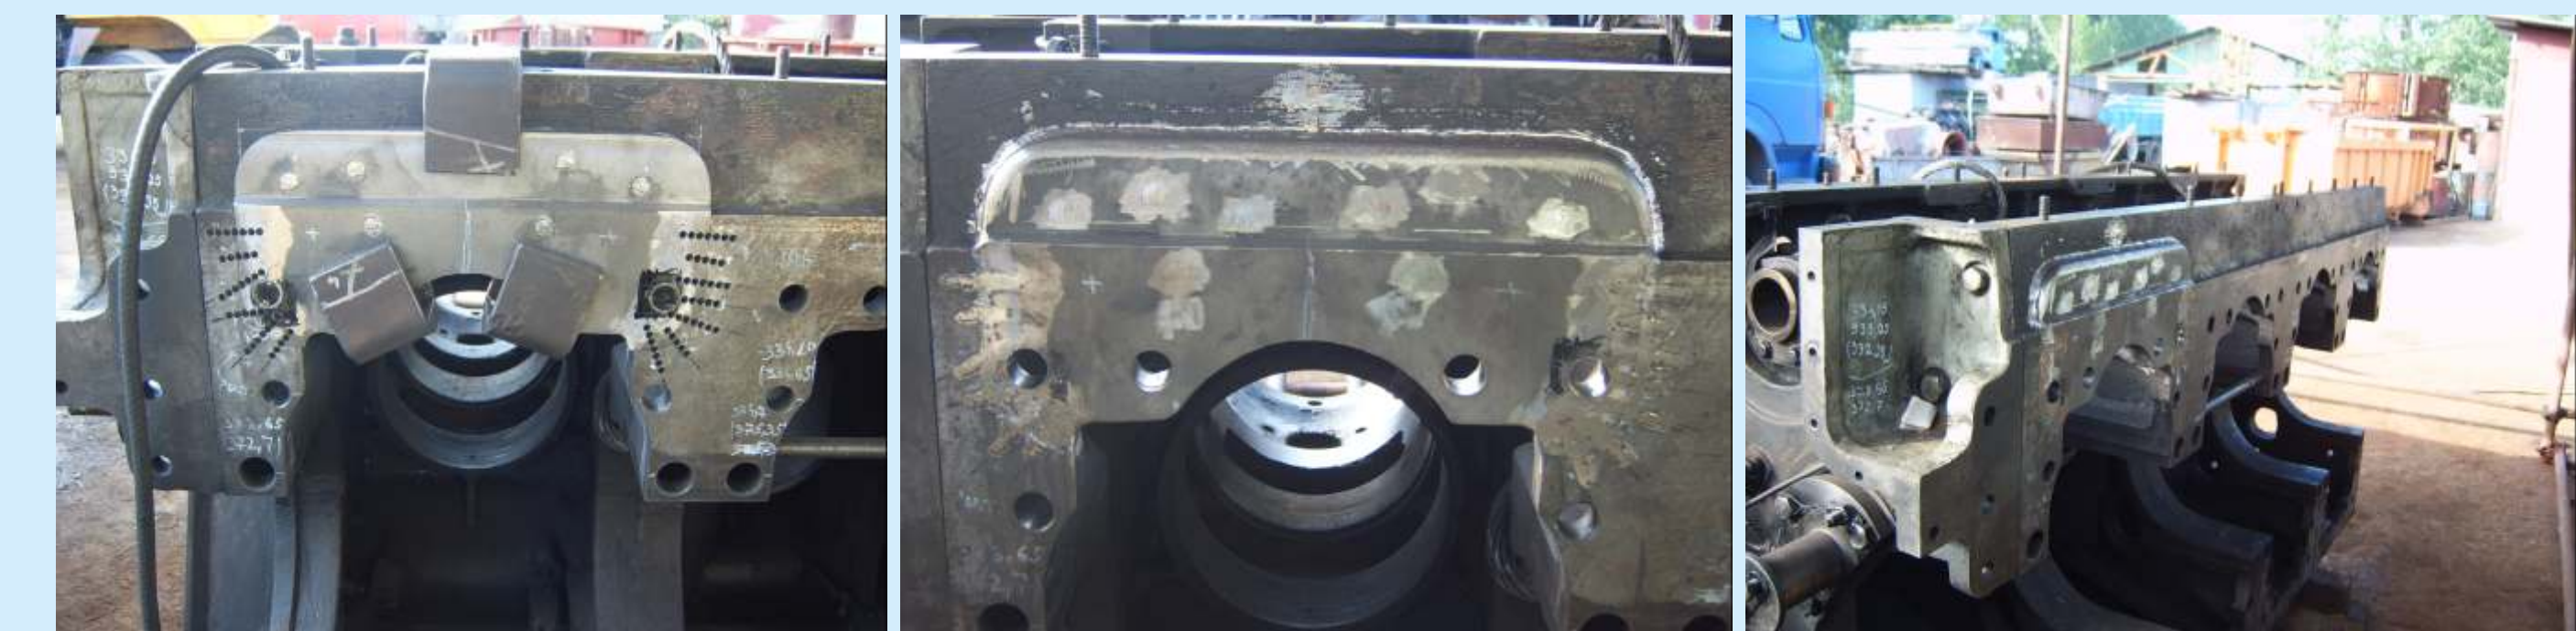
Stage of the Metallock repair for embedment of the insert to the face of the cylinder block (fig.4)

Cylinder block surface after restoration. Next is the mechanical treatment for achieving the necessary parameters of flatness and roughness, required for the proper operation of the engine (fig.5 and 6)

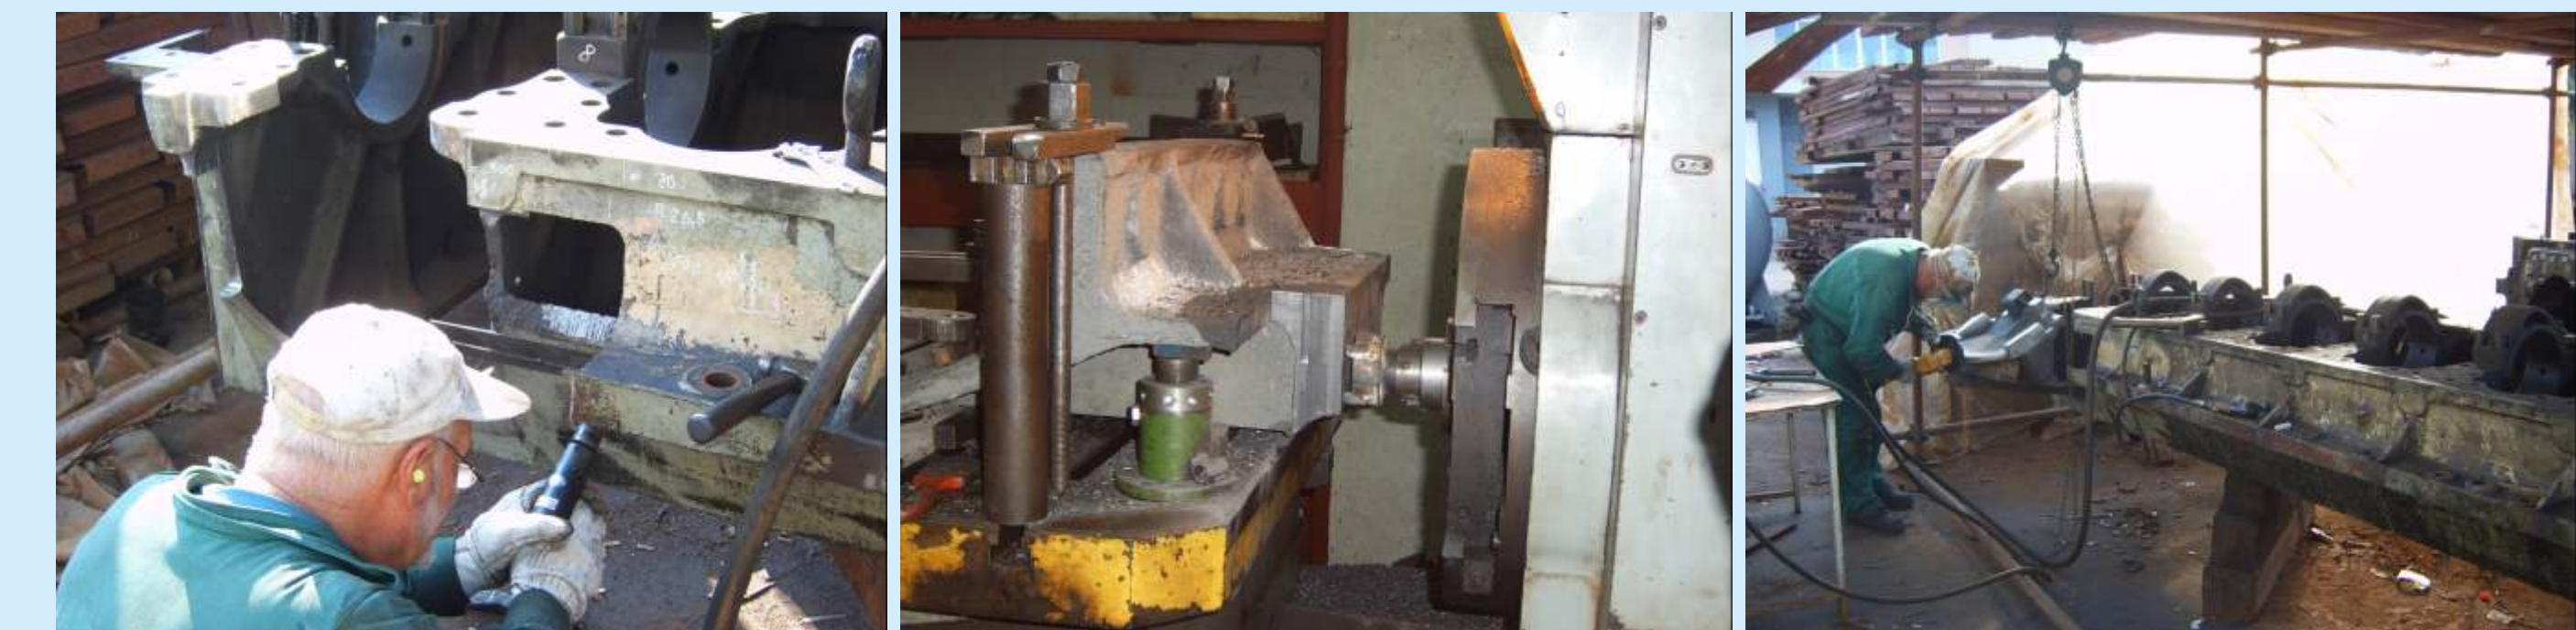
Preparation of the adjoining surfaces for embedment of the new part to the casing body (fig.7)

Stage of the mechanical processing of the casting, designated for embedding to the casing body (fig.8)

Manual alignment of the new part to the casing body (fig.9)

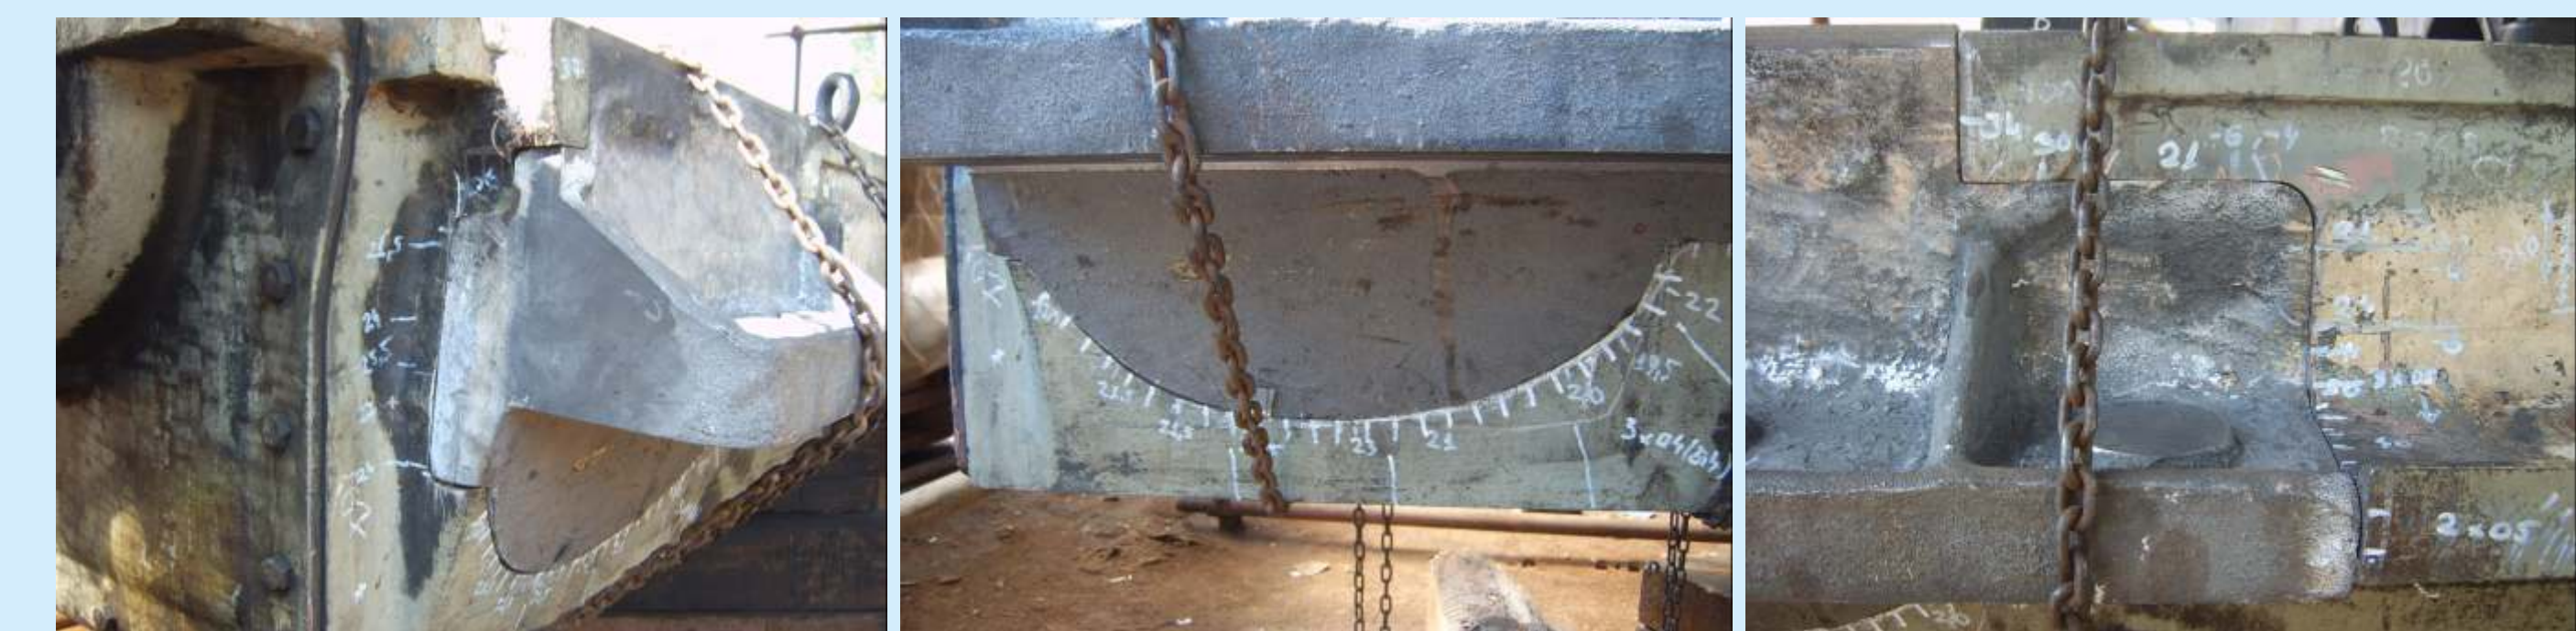
Aligned new part. Tightened and ready for embedment through the Metallock method of repair (fig.10, 11 and 12)

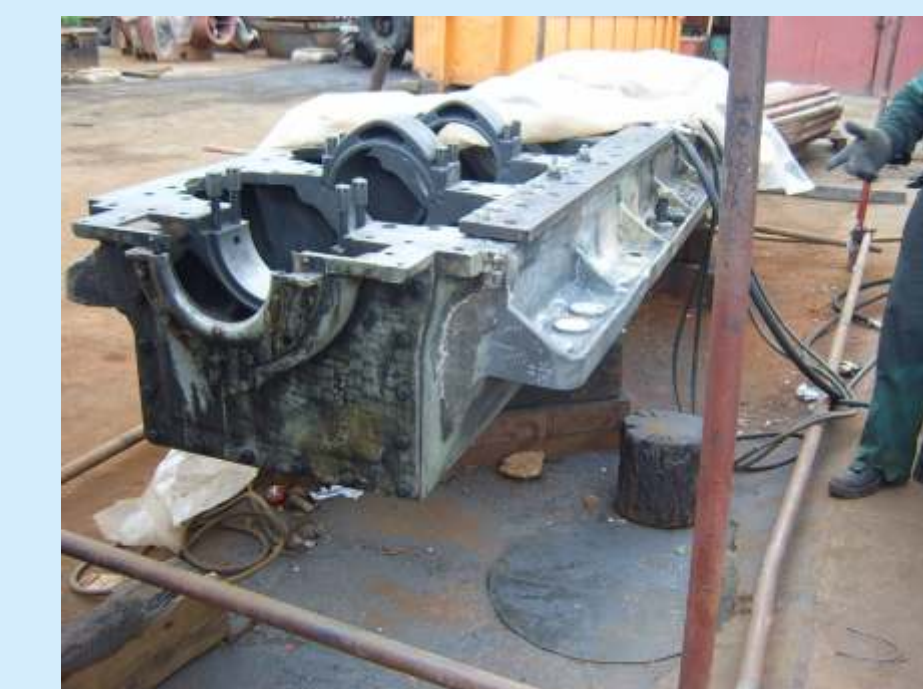
Completed Metallock repair. Preparation for holes restoration, required for engine re-assembly. Finally – machine treatment of casing surface (fig.13)
