Repair of cylinder block of main engine AKASAKA-MITSUBISHI

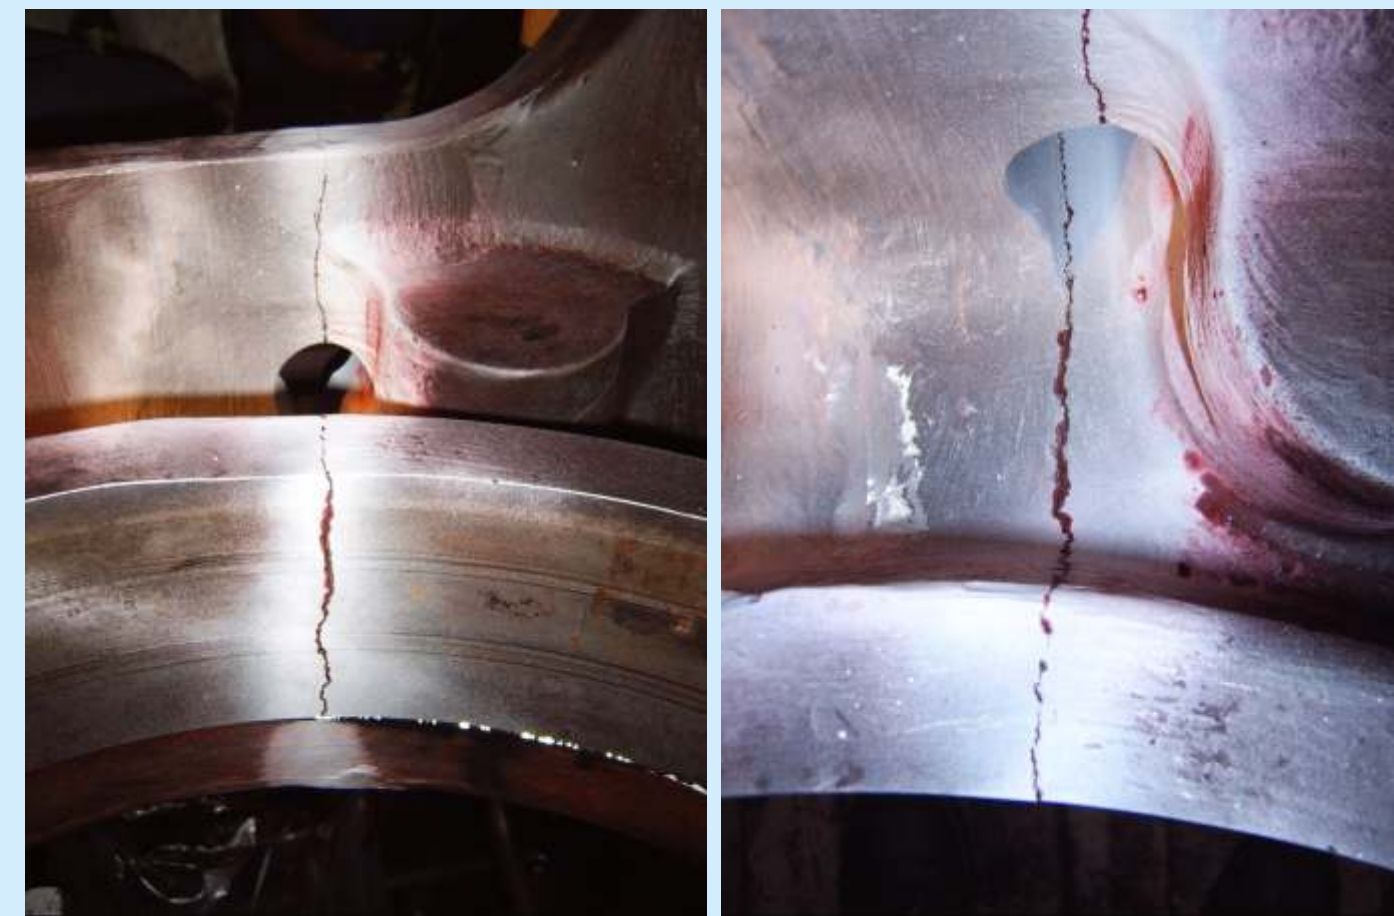
As a result of failure during operation a crack has emerged in the area of the sixth motion on the cylinder block of main engine „AKASAKA-MITSUBISHI“ 6UET52/90C (Figures 1 and 2)
